INSPECTION REPORT

For the Property at: 127 JACKSON WAY NORTHAMPTON, MA 01060

Prepared for: JANE BROWN Inspection Date: Friday, March 20, 2015 Prepared by: Edward Hamel

RE: Report No. 1004, v.3 127 Jackson Way Northampton, MA 01060

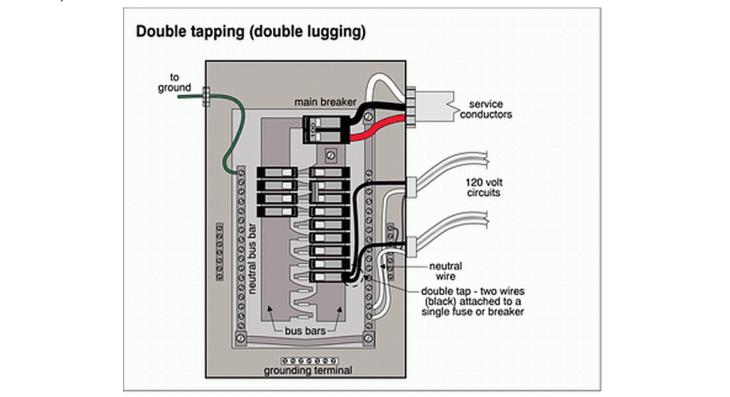
DISTRIBUTION SYSTEM \ Wiring - installation

26. Condition: • <u>Not well secured</u>
service line to outside rear should be fastened better
Location: Basement
Task: Improve
Time: Discretionary

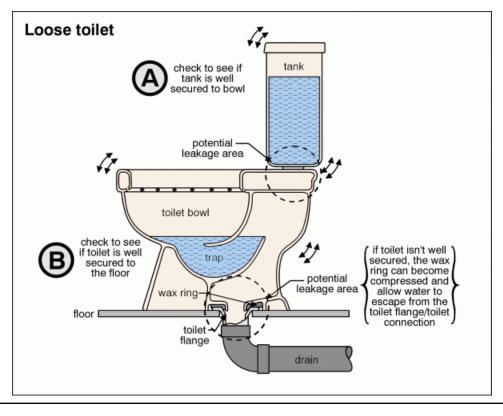
FIXTURES AND FAUCETS \ Toilet

46. Condition: • Loose Location: Second Floor **Task**: Repair
